# Manhole Inspection Summary

Manhole # **S15GG\_016MH**

Insp Date: **7/27/09 10:22 AM**

**Location** Address: **2527 BAKER ST**

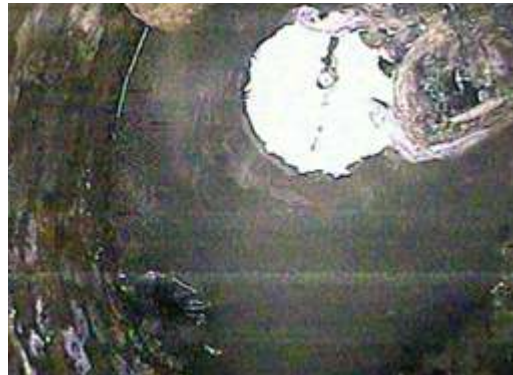
Top View

DEBRIS ON BENCH

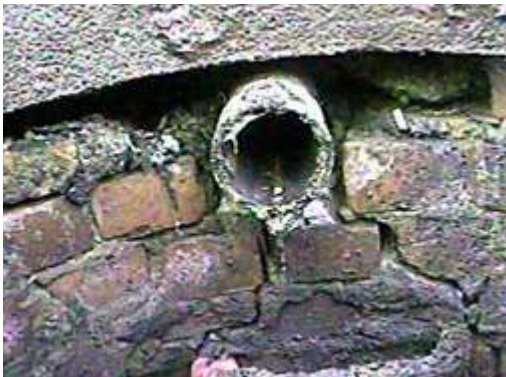
Defect 1

POSSIBLE ILLICIT CONN.
